**PHASE I
ENVIRONMENTAL SITE ASSESSMENT
FORMER RED BANK MIDDLE SCHOOL PROPERTY
3715 DAYTON BOULEVARD
RED BANK, HAMILTON COUNTY, TN
S&ME Project No. 4181-14-041**

August 5, 2014

Reference: Report of Phase I Environmental Site Assessment
Former Red Bank Middle School Property
3715 Dayton Boulevard
Red Bank, Hamilton County, Tennessee
S&ME Project No. 4181-14-041

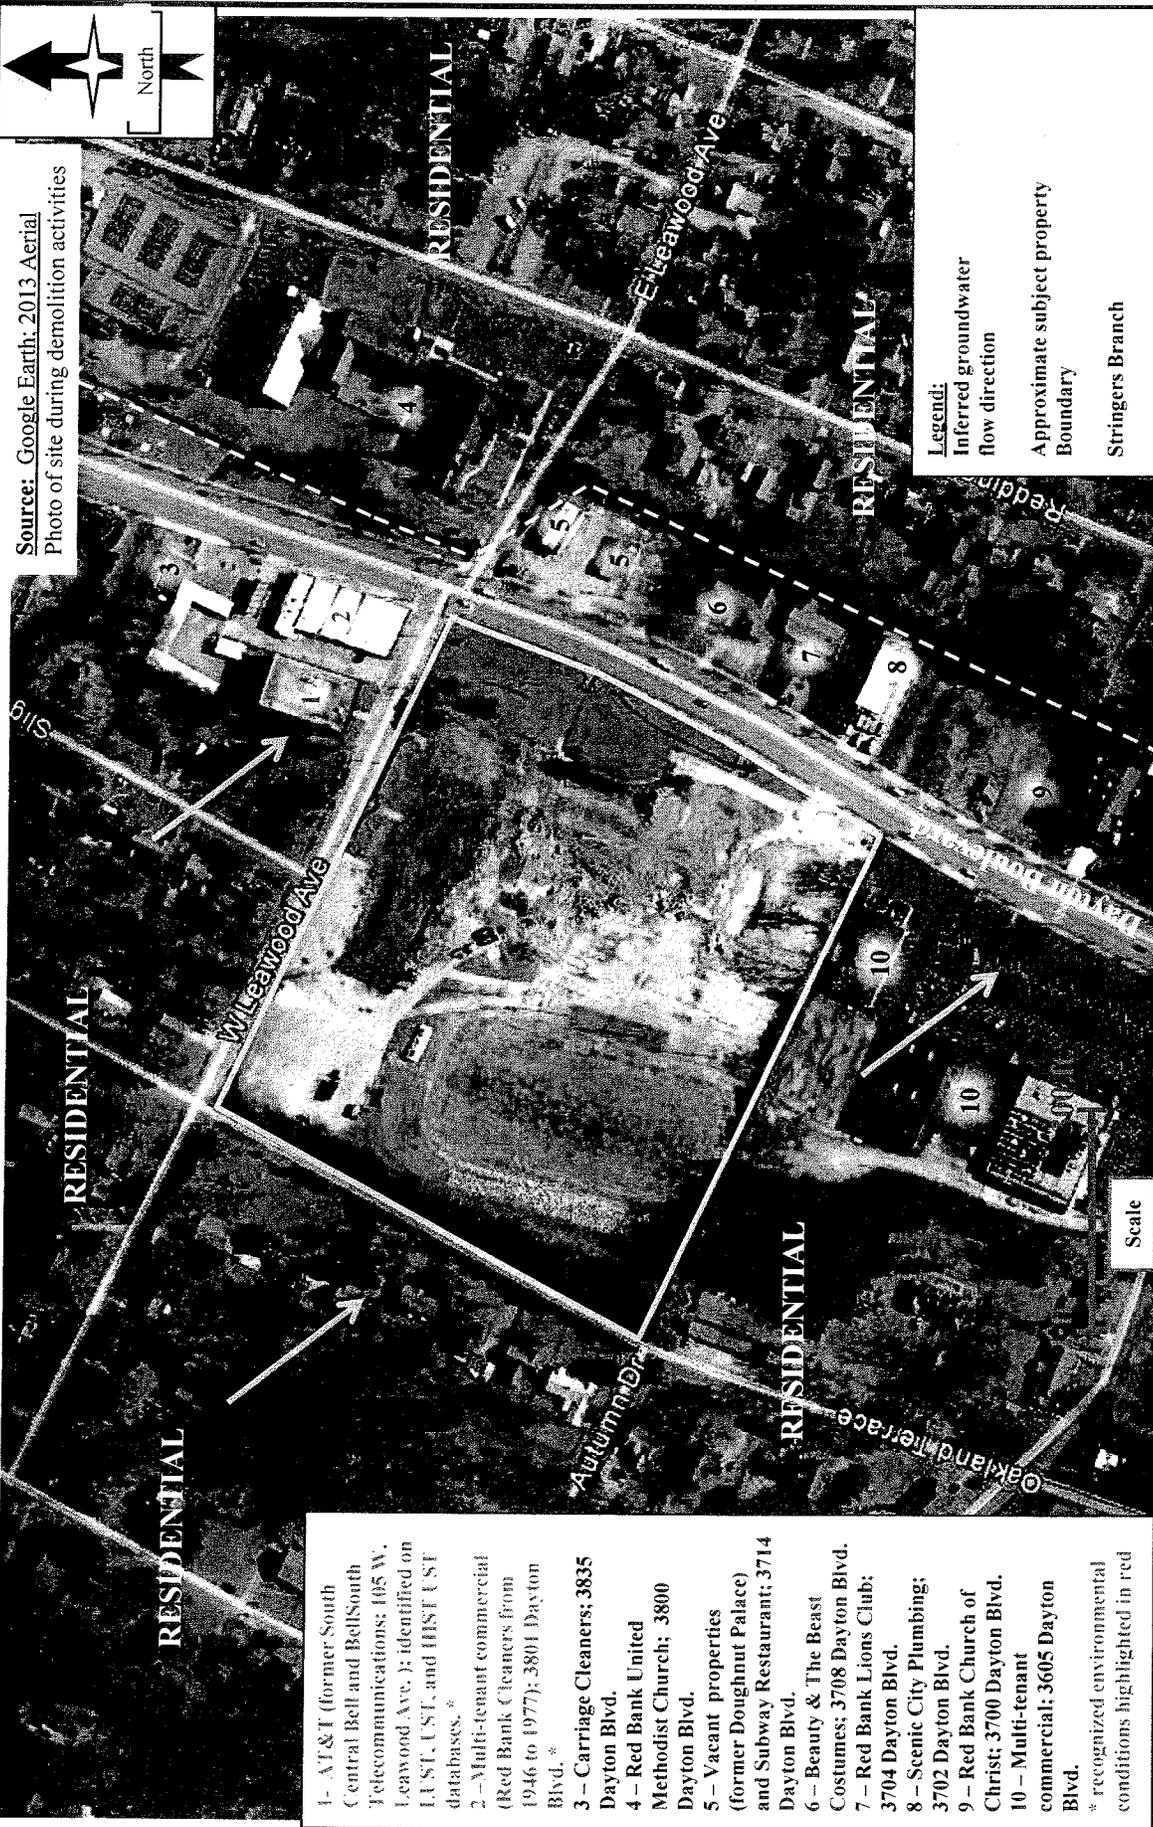
Source: Google Earth; 2013 Aerial
Photo of site during demolition activities

- Legend:
- Inferred groundwater flow direction
 - Approximate subject property Boundary
 - Stringers Branch

- 1 - AT&T (former South Central Bell and BellSouth Telecommunications; 105 W. Leawood Ave.); identified on LUST, CST, and HIRST CST databases. *
 - 2 - Multi-tenant commercial (Red Bank Cleaners from 1946 to 1977); 3801 Dayton Blvd. *
 - 3 - Carriage Cleaners; 3835 Dayton Blvd.
 - 4 - Red Bank United Methodist Church; 3800 Dayton Blvd.
 - 5 - Vacant properties (former Doughnut Palace) and Subway Restaurant; 3714 Dayton Blvd.
 - 6 - Beauty & The Beast Costumes; 3708 Dayton Blvd.
 - 7 - Red Bank Lions Club; 3704 Dayton Blvd.
 - 8 - Scenic City Plumbing; 3702 Dayton Blvd.
 - 9 - Red Bank Church of Christ; 3700 Dayton Blvd.
 - 10 - Multi-tenant commercial; 3605 Dayton Blvd.
- * recognized environmental conditions highlighted in red

Based on our review of the topographic map, groundwater in the vicinity of this facility would be expected to flow to the southeast, toward the northeast corner of the subject property. Based on the proximity, duration of operation, the absence of regulatory information regarding the tanks closure and location, in our opinion the South Central Bell/Bell South Telecommunications former UST is considered a *recognized environmental condition* in relation to the subject property.

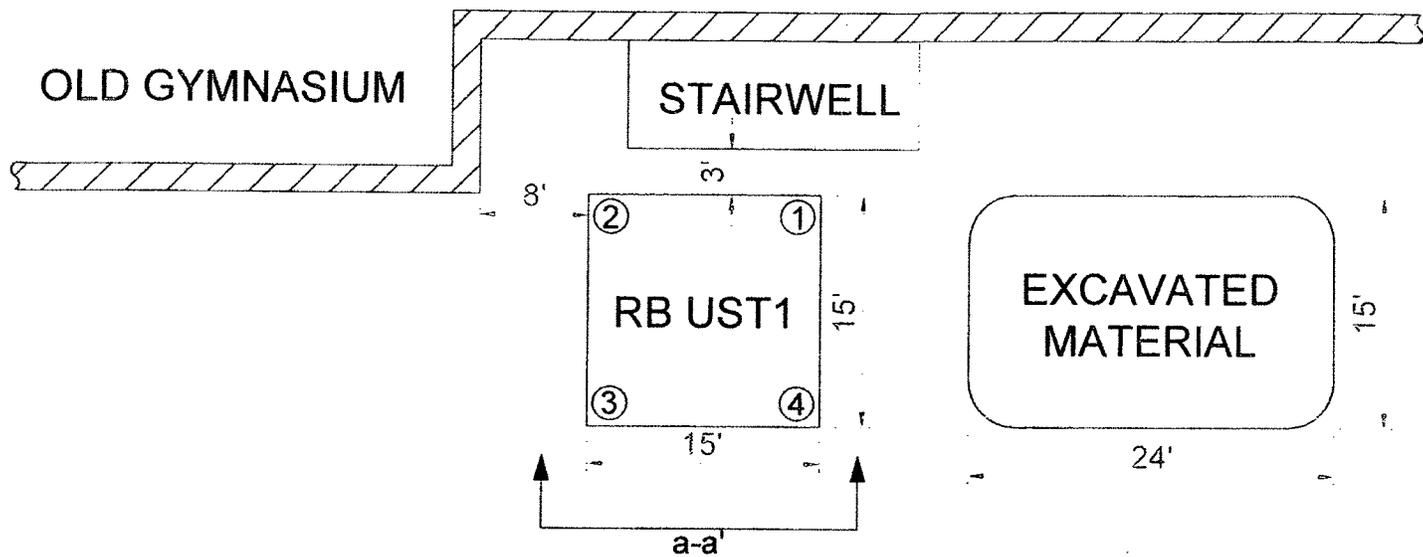
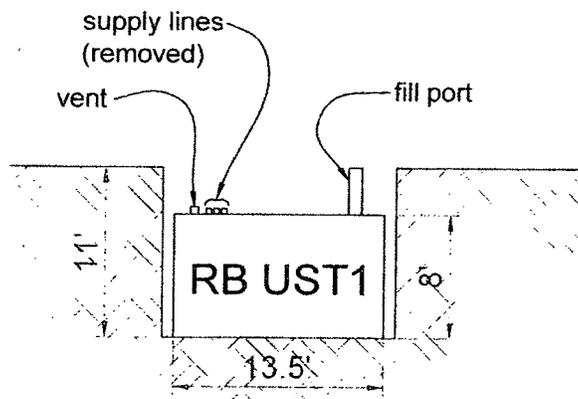
Plan View

Section View
a-a'

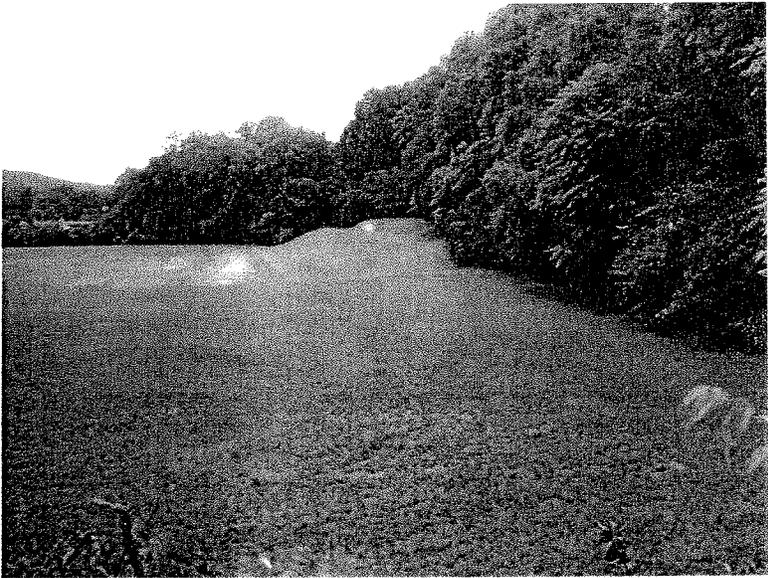
Photo 1

Date: 7/21/14 Photographer: Barry Burnette	
Location / Orientation	From near the northwest corner of subject property facing south-southwest.
Remarks	View of tree line (right) along the western boundary of subject property.

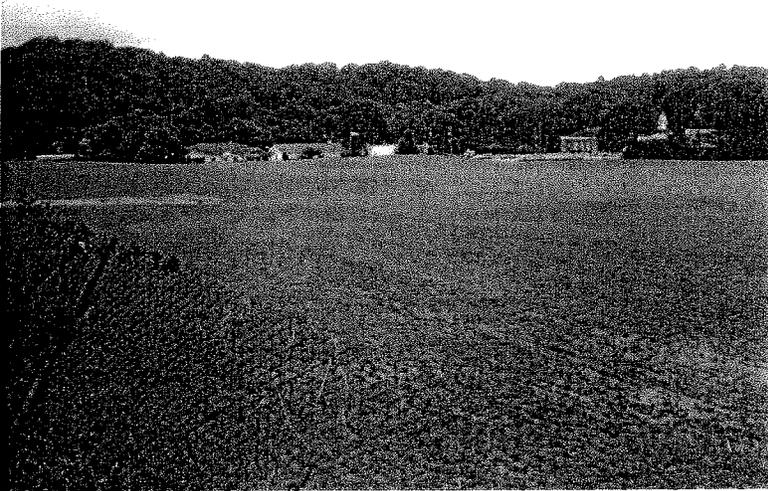
Photo 2

Date: 7/21/14 Photographer: Barry Burnette	
Location / Orientation	From near the northwest corner of subject property facing southeast.
Remarks	View of subject property. East adjoining properties on Dayton Blvd. in background.

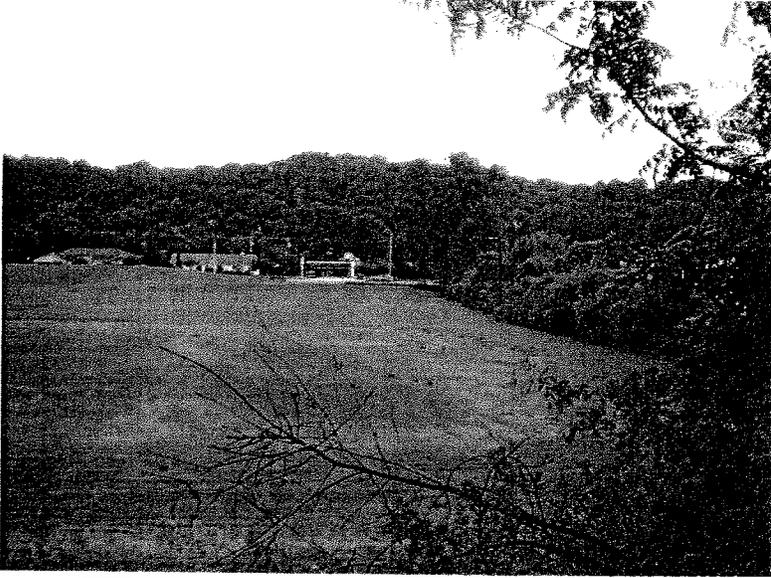
Photo 3

Date: 7/21/14 Photographer: Barry Burnette	
Location/Orientation	From near southwest corner of subject property facing east.
Remarks	View of south side of subject property. East adjoining properties on Dayton Blvd. in background.

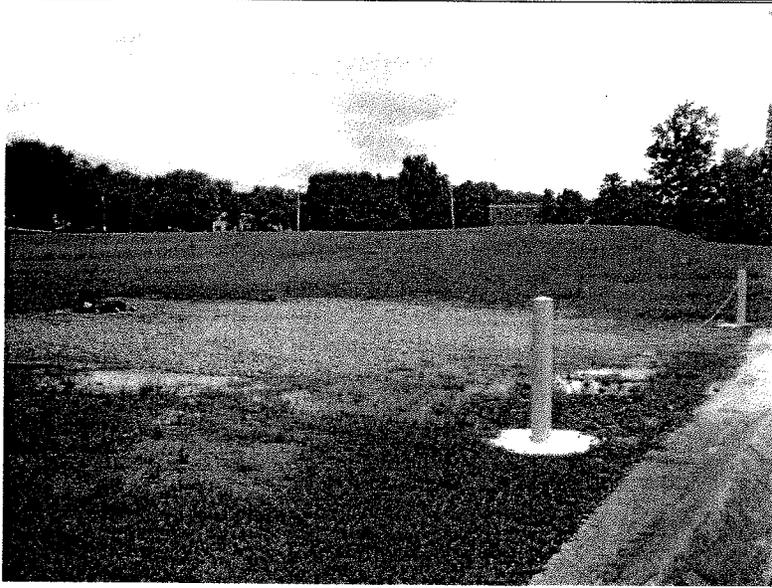
Photo 4

Date: 7/21/14 Photographer: Barry Burnette	
Location/Orientation	From near southeast corner of subject property facing north.
Remarks	View of east side of subject property. North adjoining properties on W. Leawood Ave. in background.

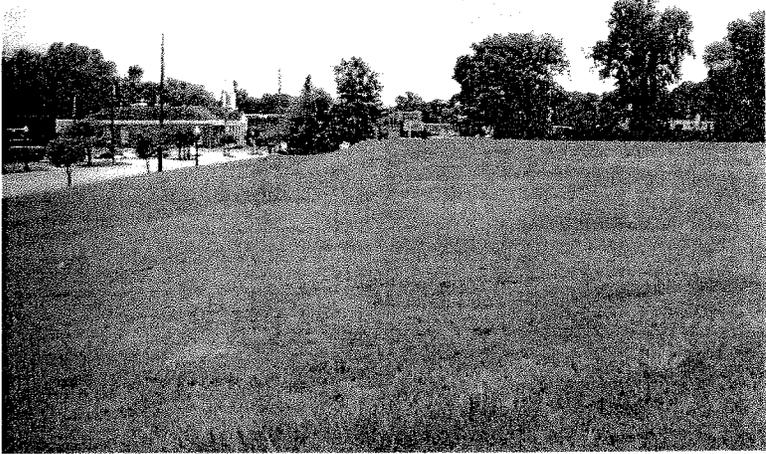
Photo 5

Date: 7/21/14 Photographer: Barry Burnette	
Location/Orientation	Northeast region of subject property facing south.
Remarks	View of subject property. South adjoining properties in background.

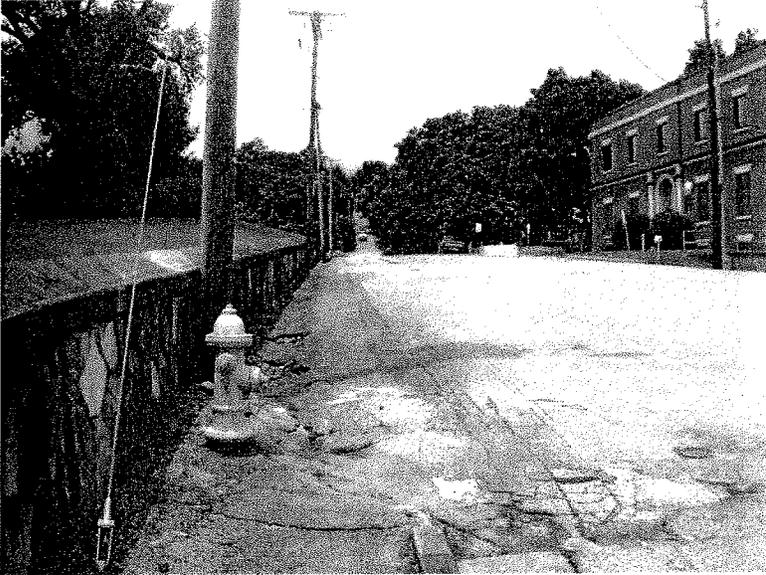
Photo 6

Date: 7/21/14 Photographer: Barry Burnette	
Location/Orientation	From near northeast corner of subject property (left) facing northwest.
Remarks	View of W. Leawood Ave and AT&T building on north adjoining property (right). Location of former South Central Bell/Bellsouth Telecommunications facilities.

- South Central Bell facility located on the adjoining property to the north, identified in the LUST, UST, and HIST UST databases was considered a *recognized environmental condition* in relation to the subject property based on proximity, topography, and absence of regulatory information regarding the tanks removal.
- The former Red Bank Cleaners, identified during historical review on a north adjoining property was considered a *recognized environmental condition* in relation to the subject property based proximity, the nature and duration of operations, and topography.

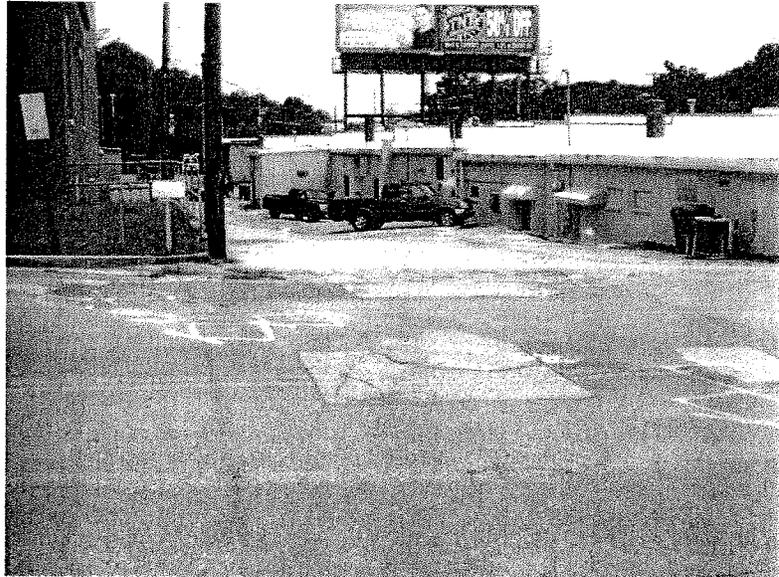
Photo 7

Date: 7/21/14
Photographer: Barry Burnette		
Location/Orientation	From north side of subject property facing north.	
Remarks	View of back of multi-tenant commercial building (right), location of former Red Bank Cleaners facility, and AT&T building (left) on north adjoining properties.

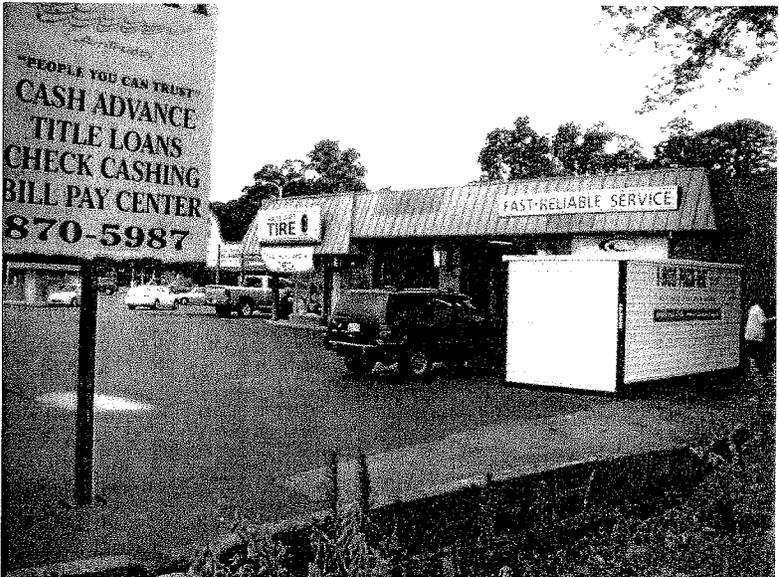
Photo 8

Date: 7/21/14
Photographer: Barry Burnette		
Location/Orientation	From near southeast corner of subject property facing southwest.	
Remarks	View of Hamilton County Tire facility (formerly Plaza Service Center) in multi-tenant commercial center on south adjoining property.

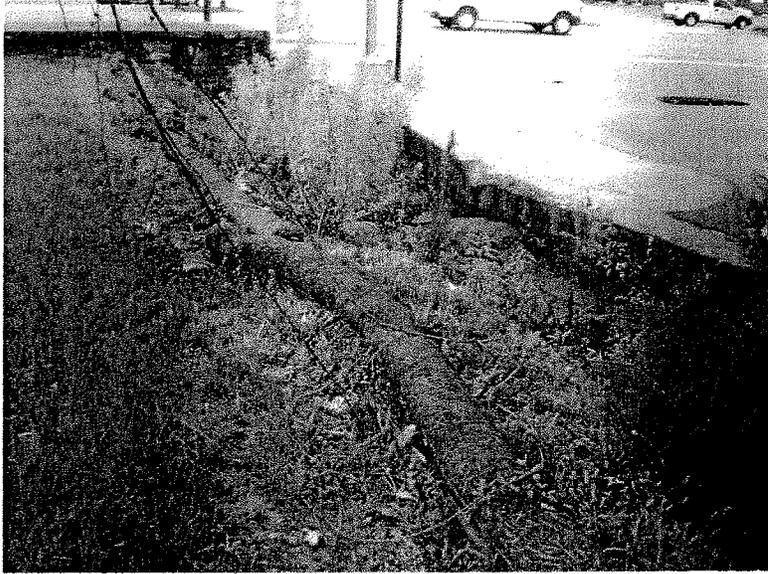
Photo 9

Date: 7/21/14 Photographer: Barry Burnette
Location/Orientation	From near southeast corner of subject property facing southwest.	
Remarks	View of drainage ditch on southwest side of property. Drainage ditch runs the length of the subject property's southern boundary and crosses beneath Dayton Blvd.

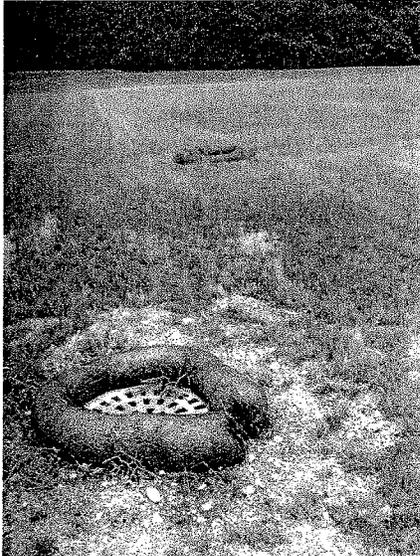
Photo 10

Date: 7/21/14 Photographer: Barry Burnette
Location/Orientation	From south side of subject property..	
Remarks	View of storm water drains on subject property. Drains are interpreted to be directed to drainage ditch in photo 9.
